The effects of rain drop impact on soil surface microtopography

T. Laburda^{*1}, D. Zumr¹, P. Kavka¹, M. Neumann¹, J. Devaty¹, N. Balenovic², L. L. Johannsen², T. Dostál¹, A. Klik², P. Strauss³

¹ Czech Technical University in Prague, Faculty of Civil Engineering, Department of Landscape Water Conservation,
² University of Natural Resources and Life Sciences, Department of Water, Atmosphere & Environment, Vienna, Austria,
³ Federal Agency for Water Management, Institute of Land and Water Management Research, Petzenkirchen, Austria

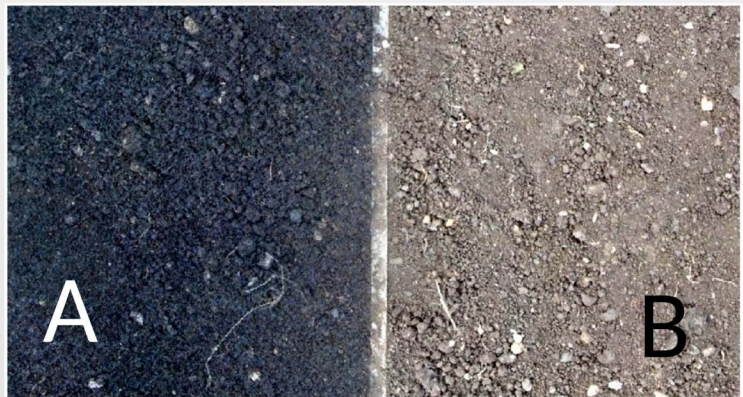
Before rainfall

- Comparison of bare and protected soil (different materials) →
- Resolution – 1 mm/pix
- Surface parameters and volume changes

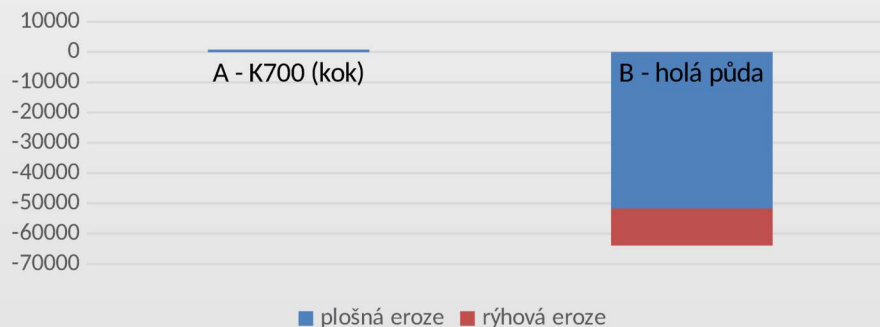
Preliminary results (only 2 experiments)

Porovnání celkové eroze (změny objemu) na ploše A a B (cm³)

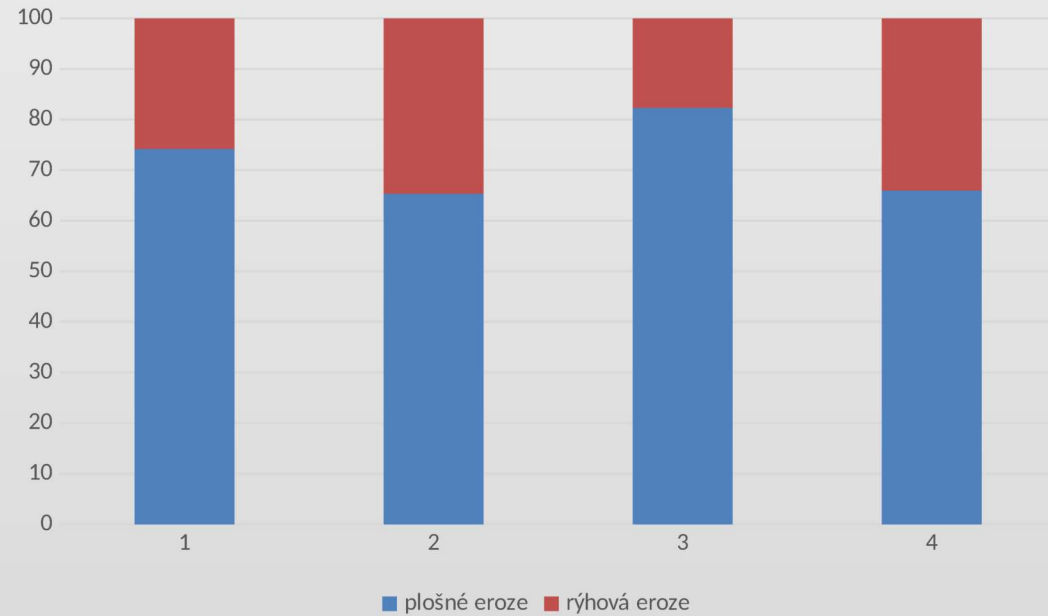
Rill vs. Interrill erosion

Podíl plošné a rýhové eroze (%)

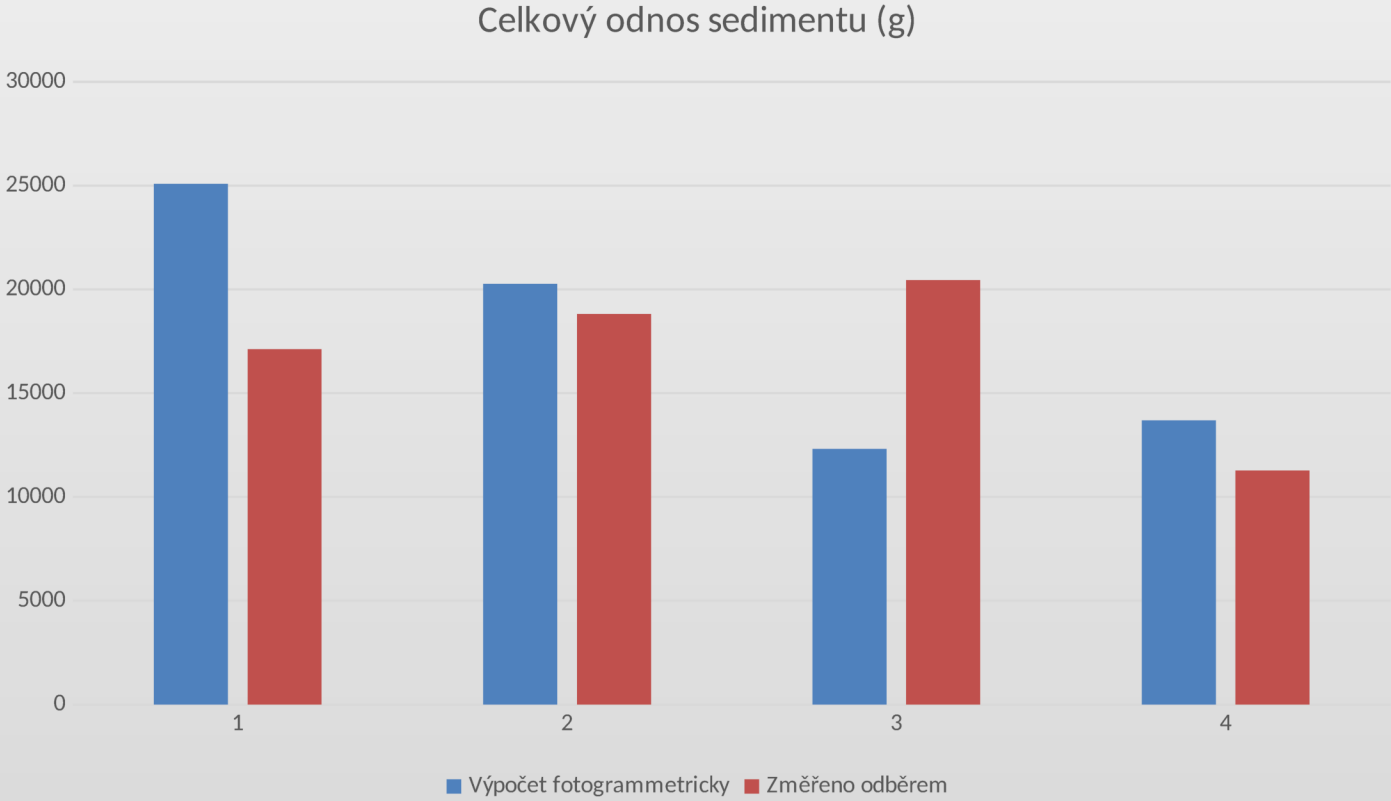
Sediment measured by photogrammetry vs. collecting buckets

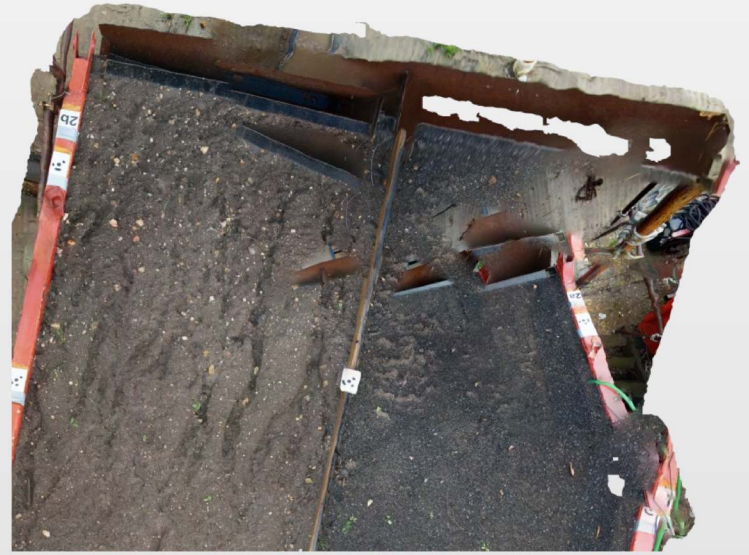
Outdoor
experiments
- high contrast
can caused
problems

- Photogrammetry is useful method for evaluating soil surface and volume changes.
- It is necessary to provide good lighting.
- Final results will be published after all scheduled experiments during this year.

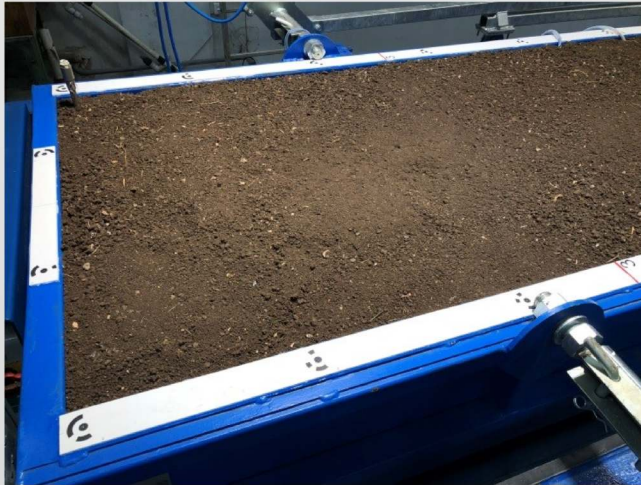
Laboratory
experiments
- uniform light is

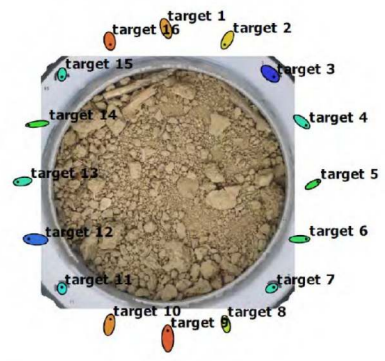
LED ring light for evenly lit imagery

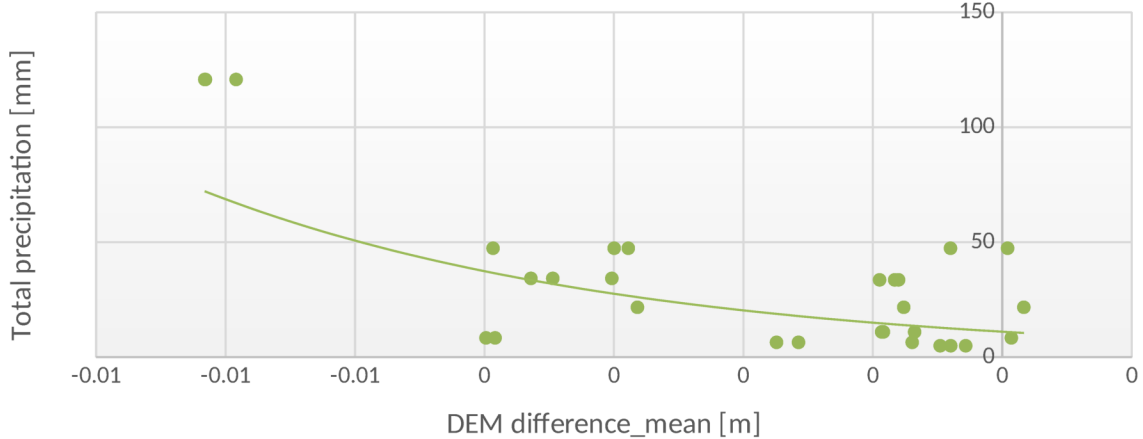
DEM difference_mean/total precipitation

- AC
- Exponential (AC)
- BC
- Exponential (BC)
- CC
- Exponential (CC)

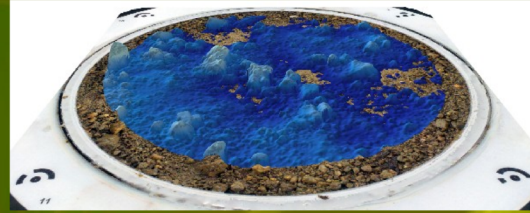
AFTER RAINFALL

„final state“

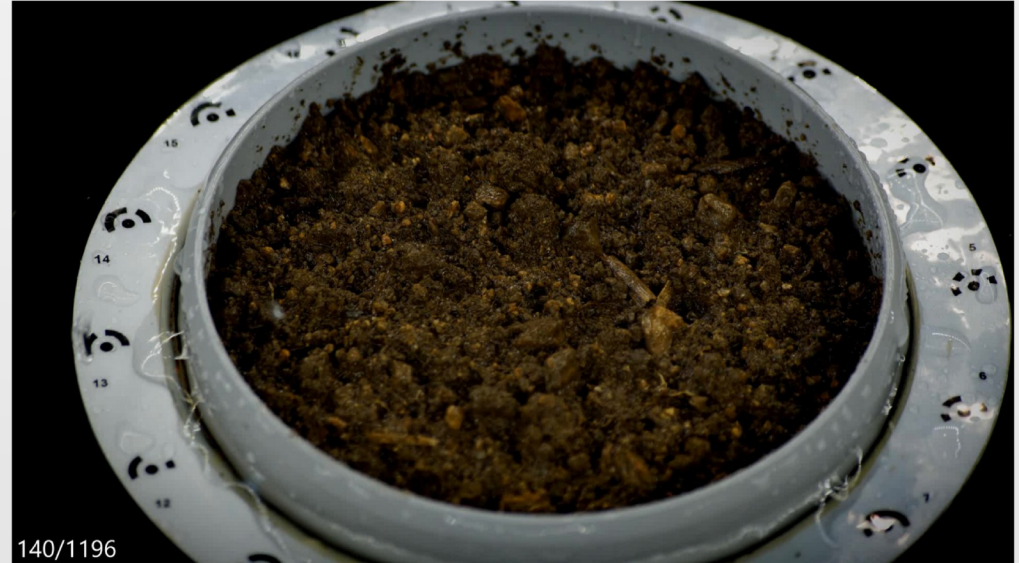
Effect of drying soil after rainfall

Cracks begin to appear on soil surface after 30 hours after rainfall with a constant drying at 27°C.

Consolidation (MEAN) caused by drying of the soil is almost the same as caused by the rainfall itself (-1,33 mm vs -1,05 mm). Roughness (STD) does not exhibit remarkable changes.
